Manhole Inspection Summary

Manhole # S21CC_033MH

Location Address: **1201 WINCHESTER ST** Cross Street: **MONROE-MCKEAN**

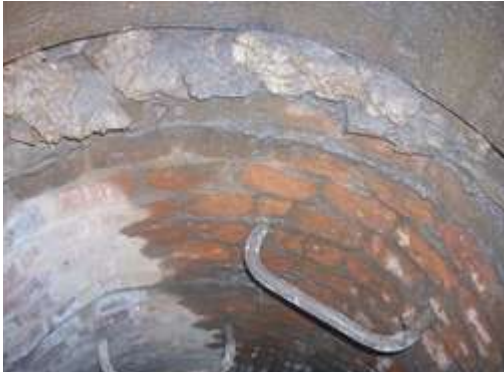
Defect 2

DEBRIS

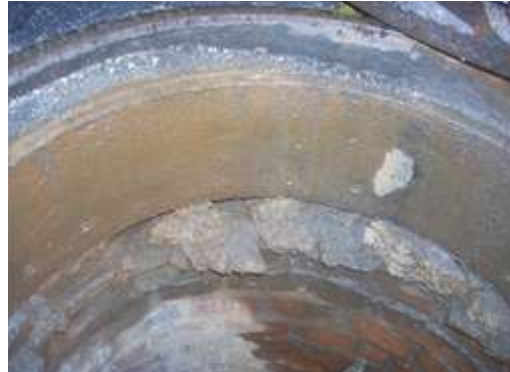
Defect 1

Condition: ☐ Sound ☐ Cracked ☐ Root Intrusion ☐ Loose Brick ☒ **Deteriorated**

CORBEL DETERIORATION

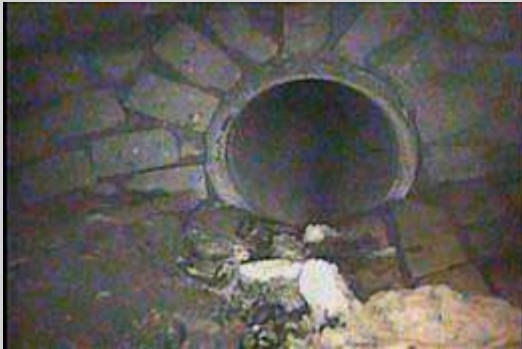
12 O'Clock Outflow

8 in. Circular Gravity Sewer
Pipe Out @ 12 O'Clock

Pipe Height: **8.4** (in.) Rod and Bar (Angled)
Pipe Material: **Clay** ☐ Pipe Lined
Invert Depth: **7.44** (ft.) Flow Characteristics: **Slow**
Deposits: ☒ None ☐ Mud ☐ Sludge ☐ Debris ☐ Grease
Silt Depth: (in.) Deposits Extent:
Infiltration: **None** Pipe Seal Cond: **Sound**

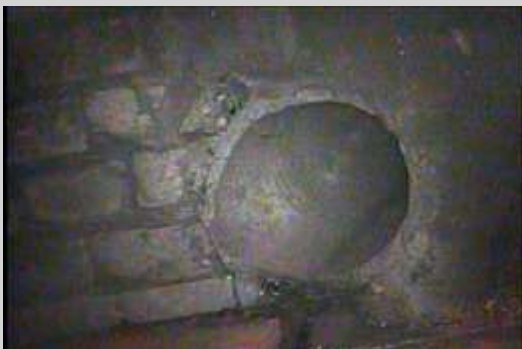
4 O'Clock Inflow

6 in. Circular Gravity Sewer
Pipe In @ 4 O'Clock

Pipe Height: **6** (in.) Rod and Bar (Angled)
Pipe Material: **Clay** ☐ Pipe Lined
Invert Depth: **6.75** (ft.) Flow Characteristics: **Slow**
Deposits: ☒ None ☐ Mud ☐ Sludge ☐ Debris ☐ Grease
Silt Depth: (in.) Deposits Extent:
Infiltration: **None** Pipe Seal Cond: **Sound**
